Manhole Inspection Summary

Manhole # S27M__028MH

Insp Date: **5/2/08 10:21 AM**

Location Address: **1184 W Ostend rd**

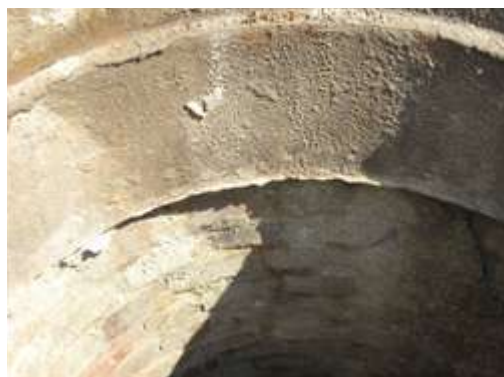
Defect 5

Infiltration: ☐ None ☒ **Joint** ☐ Cracks ☒ **Mortar** ☐ Roots ☒ **Wall**

chimney flow wall, mortar, joint

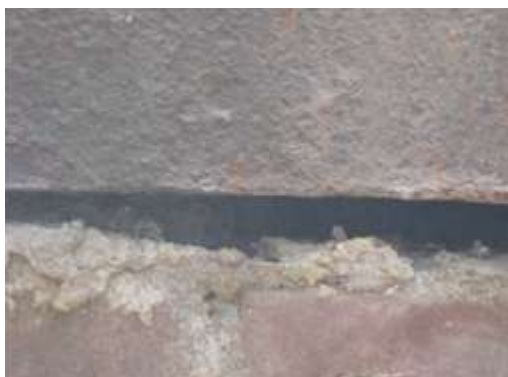
Defect 4

Condition: ☐ Sound ☐ Cracked ☐ Root Intrusion ☐ Loose Brick ☒ **Deteriorated**

chimney cond deteriorated

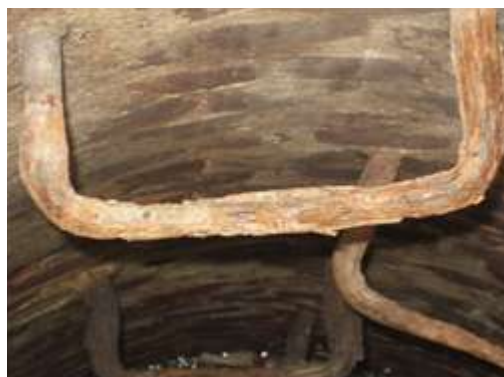
Defect 2

Steps Count: **5** Missing: **0** ☒ **Corroded**

corroded steps

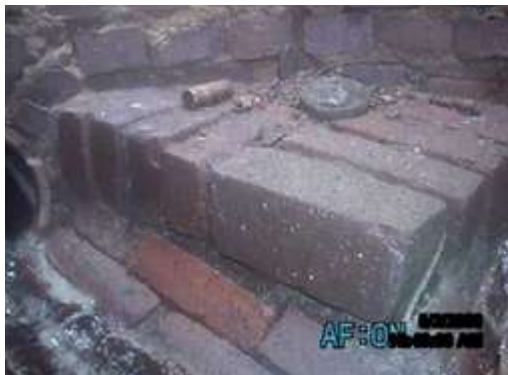
Defect 5

Condition: ☐ Sound ☐ Cracked ☐ Root Intrusion ☐ Deteriorated ☐ Leaks ☒ **Debris**

bench cond debris

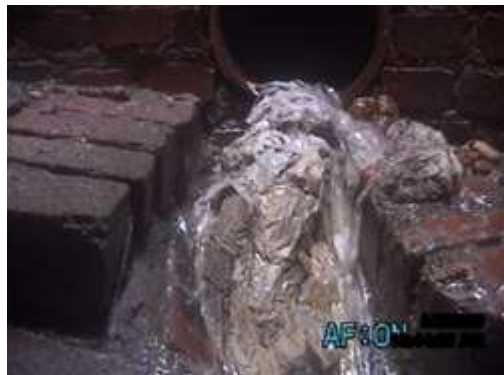
Defect 1

Condition: ☐ Sound ☐ Cracked ☐ Root Intrusion ☐ Deteriorated ☐ Leaks ☒ **Debris**

channel cond debris

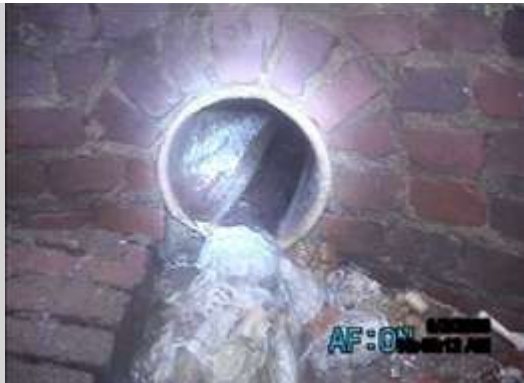
9 O'Clock Inflow

Deposits: ☐ None ☐ Mud ☐ Sludge ☒ **Debris** ☐ Grease

Silt Depth: **3** (in.) Deposits Extent: **Medium**
